TOPIC Alt Loennewitz Airfield

DATE OF CONTENT 4 to 17 October 1952

DATE OBTAINED                      DATE PREPARED 25 November 1952

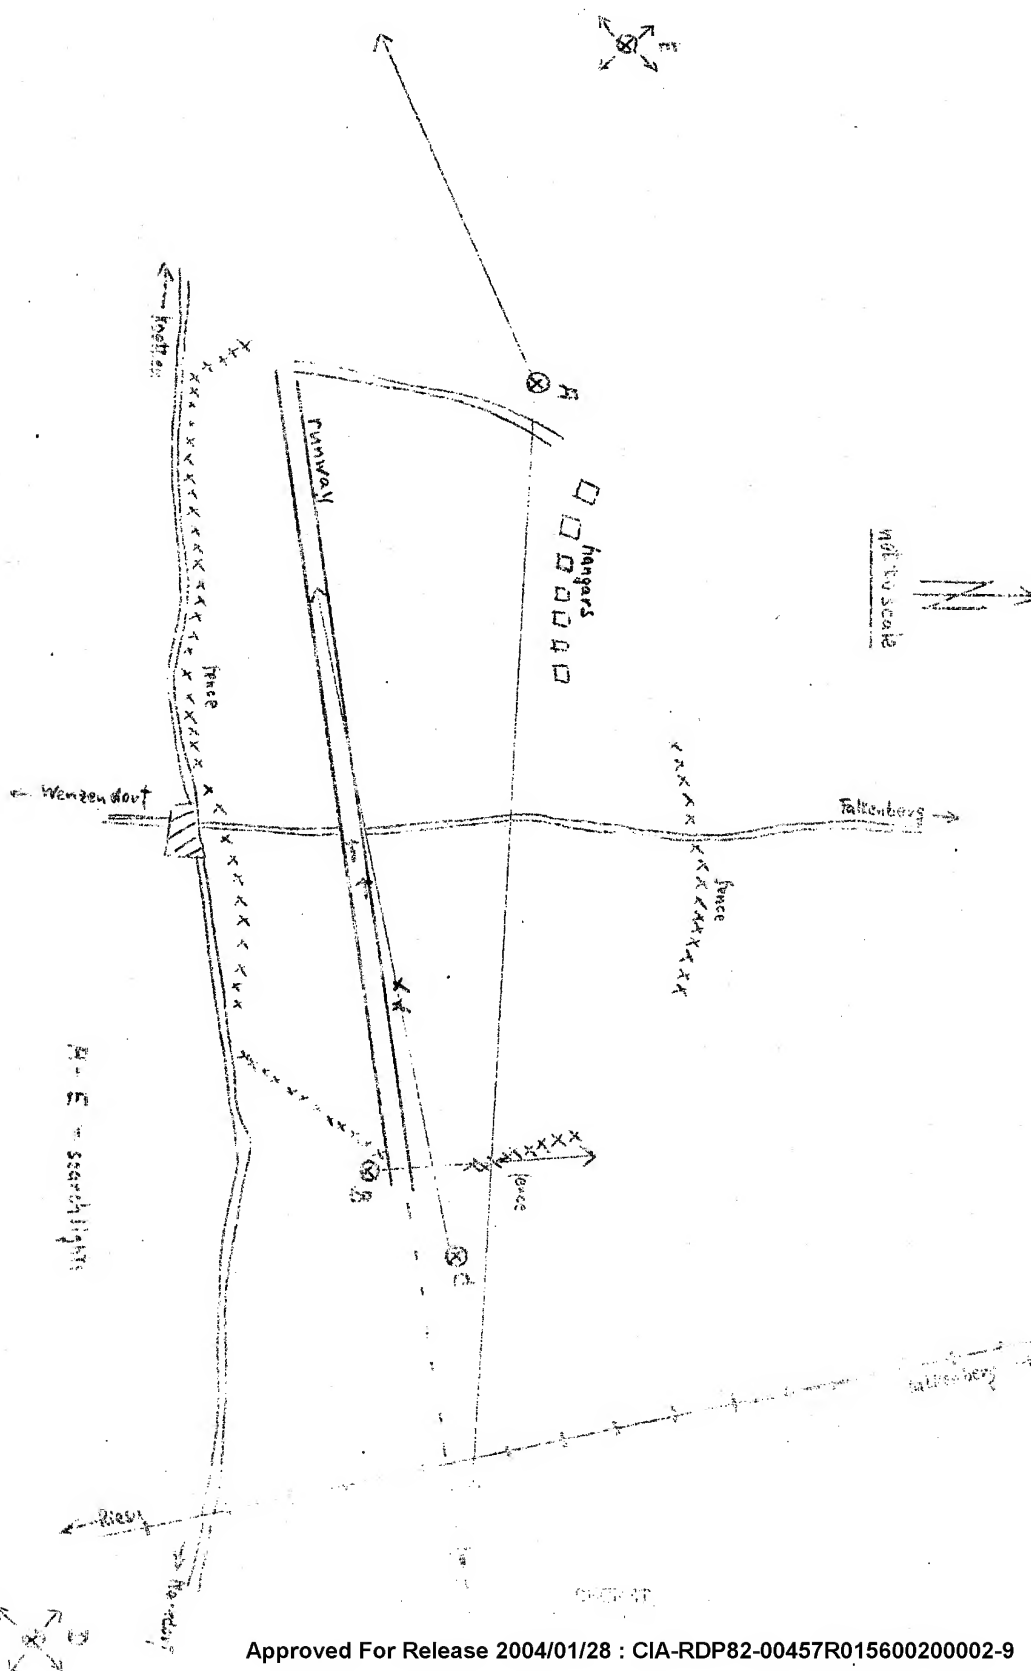
Annex

- 25X1 2. [ ] Comment. For location of searchlights A through E, see Annex. The very detailed description of the night flying conducted at the field shows that the Russians use searchlights extensively to facilitate the landing and orientation of their aircraft.
